Waterproofing Systems

# Horizontal barriers against rising damp in masonry

issued: 02/2020

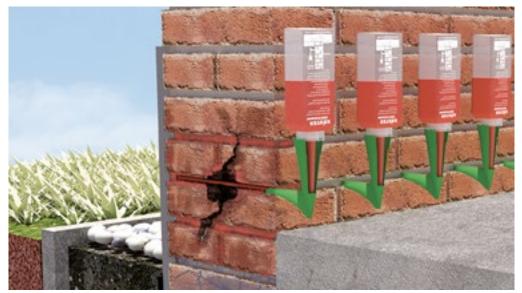
The system consists of the KÖSTER Crisin 76 Concentrate cartridge, the KÖSTER Capillary Rod, and the KÖSTER Suction Angle.

Schematic representation. Actual circumstances may differ in reality.

The patened KÖSTER Suction Angle System is the result of decades of experience and development work by the KÖSTER BAUCHEMIE AG. The horizontall barrier is distributed through the capillary transport itself, stopping the rising damp with its own physical cause.

The KÖSTER Capillary Rod acts like a wick, one end is inserted into the wall and the other end into the KÖSTER Suction Angle. From there, it draws the injection liquid into the wall. The KÖSTER Capillary Rod is available in lengths of 45 or 90 cm.

This is a crucial advantage not only when installing horizontal barriers into hollow bricks, vertically perforated bricks or old and cracked masonry, but also for all other conditions. The method is transparent and allows easy control of the distribution of the injection material into the wall. It also gives security in the cost calculation for the installation of a horizontal barrier since the amount of material needed can be easily and accurately determined (the flow of the material is achieved through the rods and therefore there is no possibility of material run off).
